Manhole Inspection Summary

Manhole # S55G__005MH

Insp Date: **4/22/08 9:23 AM**

Location Address: **319 south dean street**

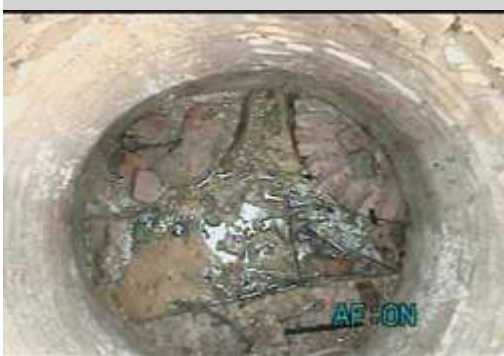
Defect 1

Condition: ☐ Sound ☐ Cracked ☐ Root Intrusion ☒ **Loose Brick** ☐ Deteriorated

Condition: ☐ Sound ☐ Cracked ☐ Root Intrusion ☐ Deteriorated ☐ Leaks ☒ **Debris**

Corbel loose bricks, bench and channel debris

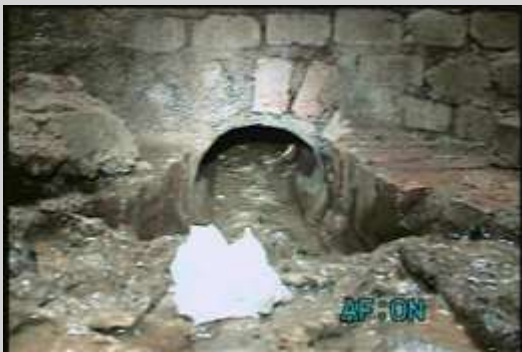
12 O'Clock Outflow

8 in. Circular Gravity Sewer
Pipe Out @ 12 O'Clock

Pipe Height: **0** (in.) Direct
Pipe Material: **Clay** ☐ Pipe Lined
Invert Depth: **7.50** (ft.) Flow Characteristics: **Slow**
Deposits: ☐ None ☐ Mud ☒ Sludge ☒ Debris ☐ Grease
Silt Depth: **2** (in.) Deposits Extent: **Medium**
Infiltration: **None** Pipe Seal Cond: **Unknown**

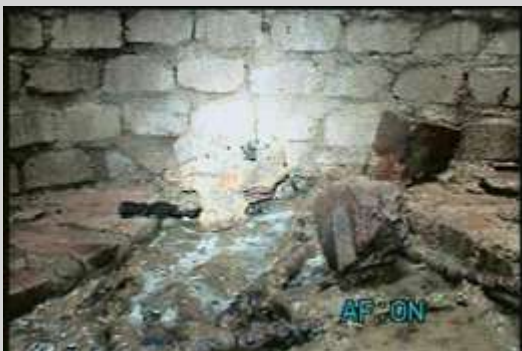
3 O'Clock Inflow

8 in. Circular Gravity Sewer
Pipe In @ 3 O'Clock

Pipe Height: **0** (in.) Direct
Pipe Material: **Clay** ☐ Pipe Lined
Invert Depth: **7.00** (ft.) Flow Characteristics: **Slow**
Deposits: ☐ None ☐ Mud ☐ Sludge ☒ Debris ☐ Grease
Silt Depth: **8** (in.) Deposits Extent: **Heavy**
Infiltration: **None** Pipe Seal Cond: **Unknown**
